CASE FILE

Basildon Council

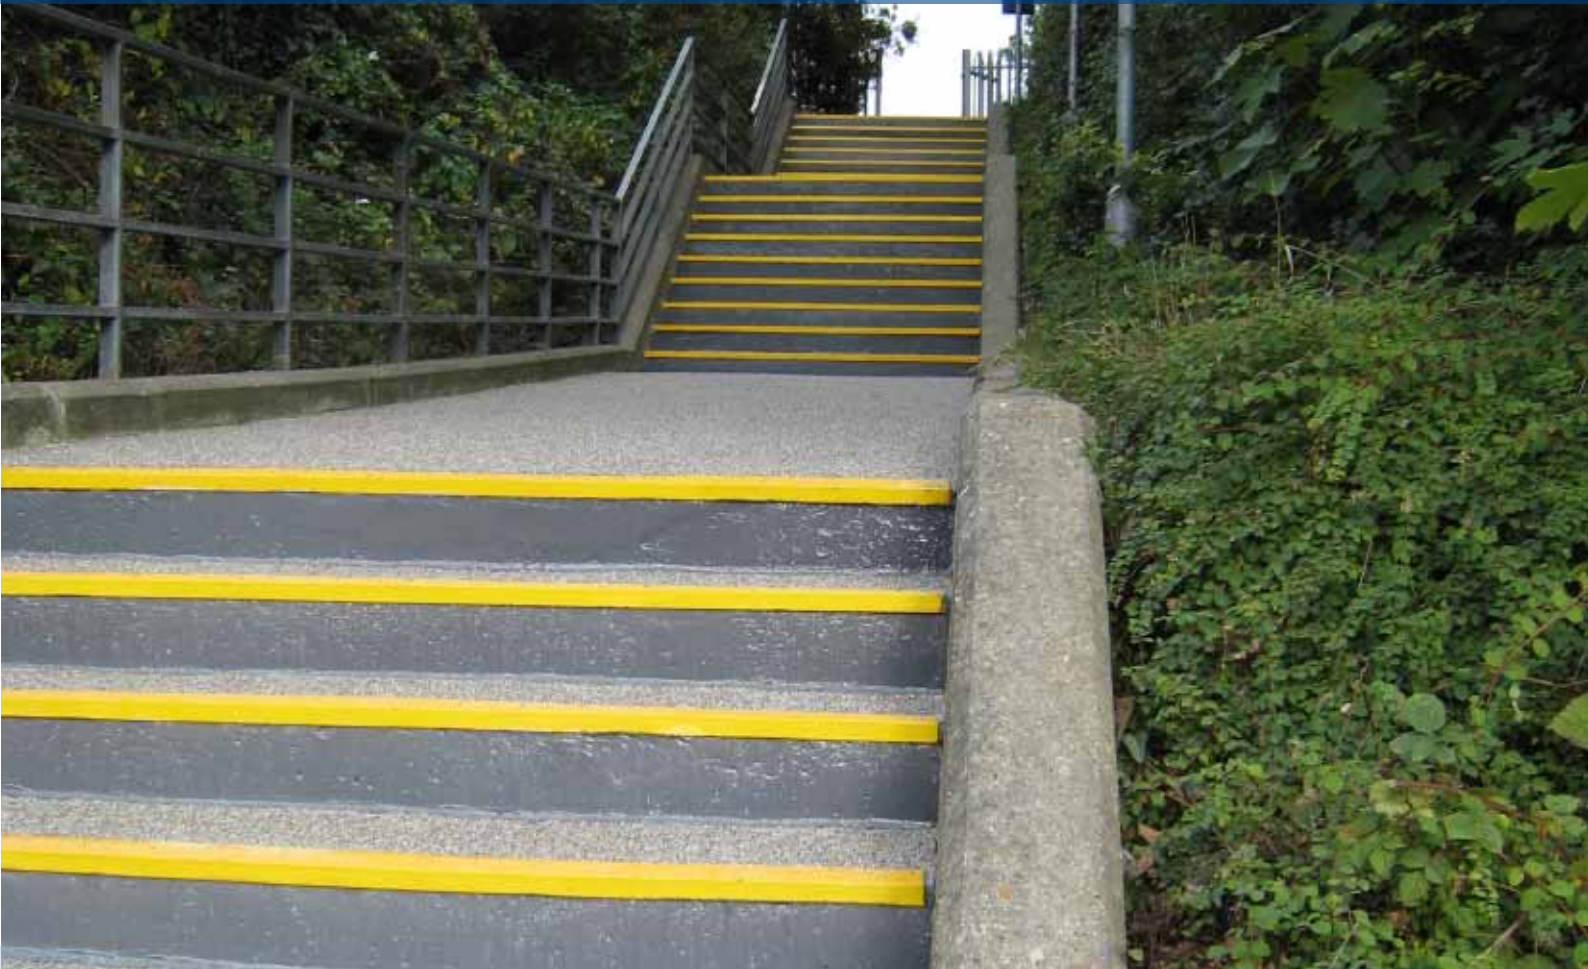
We were requested by BTCM to provide our recommendations for a set of steps which lead to a car-park area located near Basildon Market. The existing staircase had checker plate nosings on each step which had become loose and rusty and were causing a potential trip hazard to pedestrians.

The steps also had a light screed applied behind the nosing and each landing area - to build-up the height. However, due to the insufficient depth in the original screed, the material was cracking and was de-bonding from the surface.

Richco recommended that the original screed and checker-plate nosings were removed and disposed of. The steps and landing areas were then fully prepared prior to the installation of our Anti-Slip System.

Richco Anti-Slip System was then applied to all steps, risers and landing areas in a colour chosen by the client. All steps had Richco Fibreglass Nosings installed in yellow to provide an anti-slip nosing in a contrasting colour.

The finished system provided a practical, hardwearing but decorative anti-slip surface to the pedestrian staircase.
